# Manhole Inspection Summary

Manhole # S39GG\_025MH

Insp Date: **3/28/07 12:33 PM**

**Location** Address: **832 PRESTON ST**

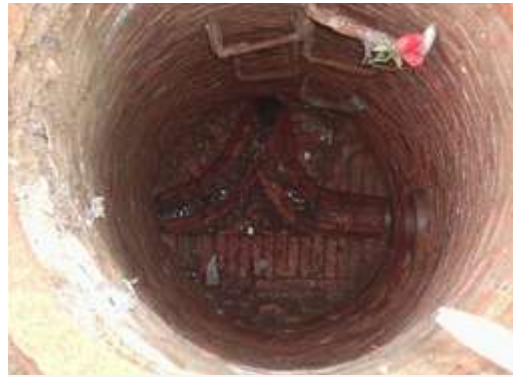
Top View

Corroded steps. Bench and Channel debris.

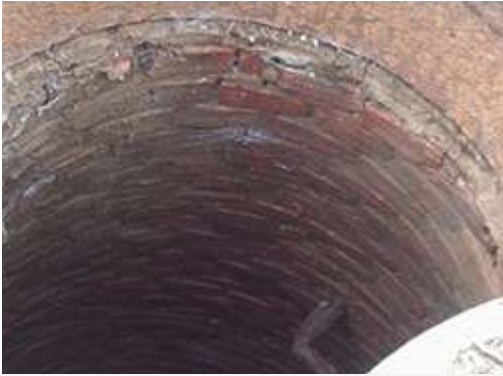
Defect

Adjustment deterioration and infiltration.

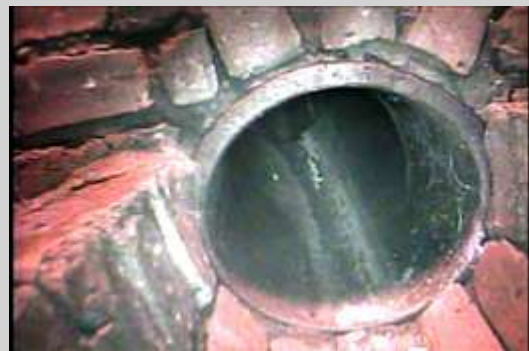
### Drop In @ 3 O'Clock

Channel deterioration.

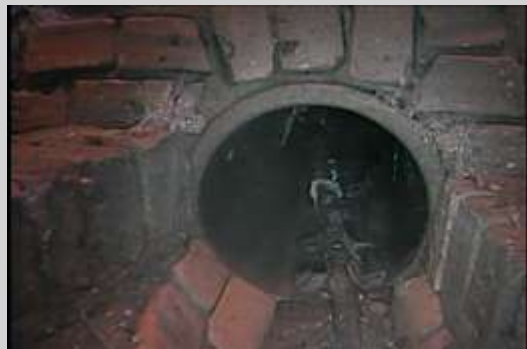
Pipe In @ 9 O'Clock

Deposits: ☐ None ☐ Mud ☐ Sludge ☒ **Debris** ☐ Grease

Deposits Extent: **Light**
